ASCE 41-17 Tier 1 Seismic Evaluation

Building Name: Cogeneration Plant CAAN ID: 1374 Auxiliary Building ID: 1374.1 Address: 209 Frank Schlessinger Way, Berkeley, CA Site location coordinates: Latitude 37.87019 Longitudinal -122.26341

UCOP SEISMIC PERFORMANCE LEVEL (OR "RATING") BASED ON TIER 1 EVALUATION FINDINGS: IV

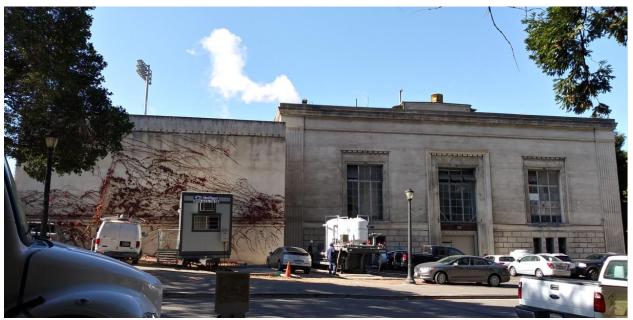
Figure A.1 East Elevation of the Combined Buildings of the Central Plant (Cogeneration Plant is to left, Central Heating is to right)

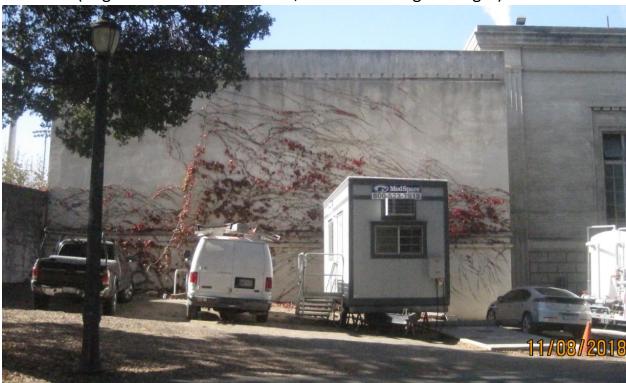
Figure A.2 East Elevation of Cogeneration Plant, specifically. Note lack of openings that is common for the east, south and west faces.

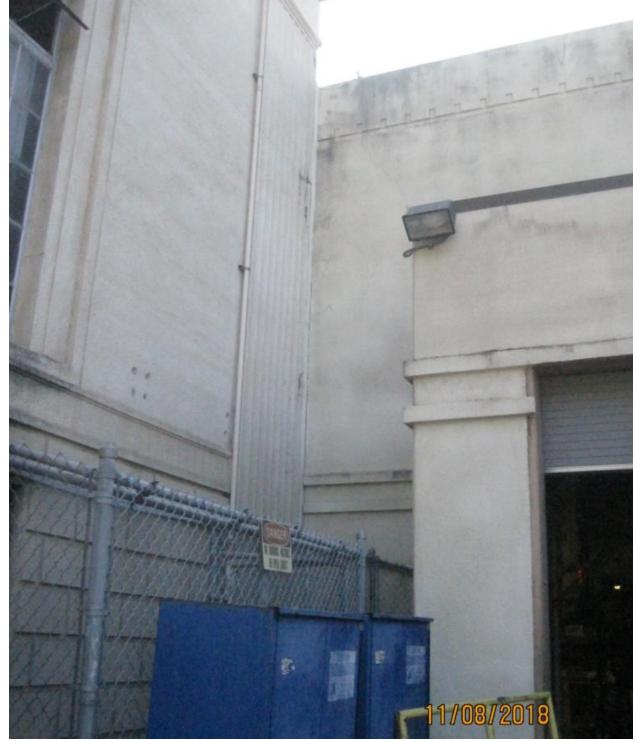
The 4" seismic separation between the Cogeneration Plant and the Central Plant would correspond to a 1.4% total drift between the two buildings in order for contact to occur. The walls of the Cogeneration Plant are strong, both in- and out-of-plane. Both buildings are reinforced concrete shear wall buildings with significant area of wall in each direction.

Figure A.3 Intersection of Central Heating Plant (at left) and North face of Cogeneration Plant (at right) (note vertical gray line which covers the 4" seismic separation between the buildings)

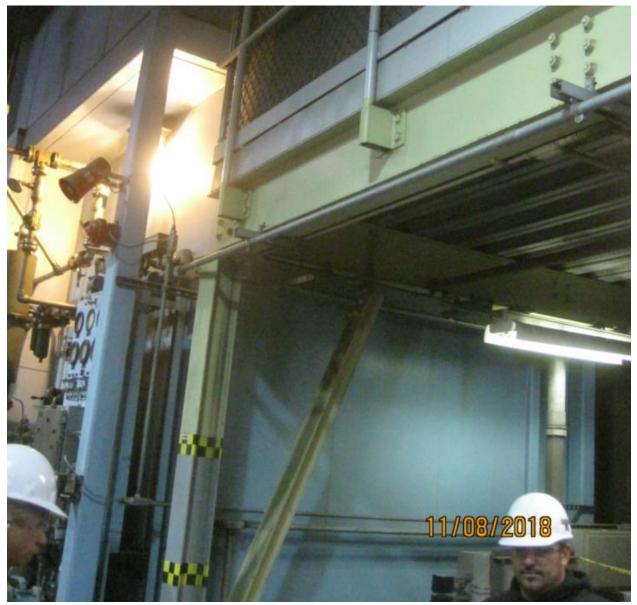
While there are no identified Tier 1 deficiencies, the braces that support the western-most mezzanine are noted to use "vertical slotted holes" at the upper end. While it is likely that the vertical slotted holes would prevent gravity load from being distributed to the braces, it is unclear how lateral load could be resisted without developing a vertical component in the braces.

Figure A.4 West Mezzanine (note concentric brace – vertical slotted bolts can just be seen at top of brace)

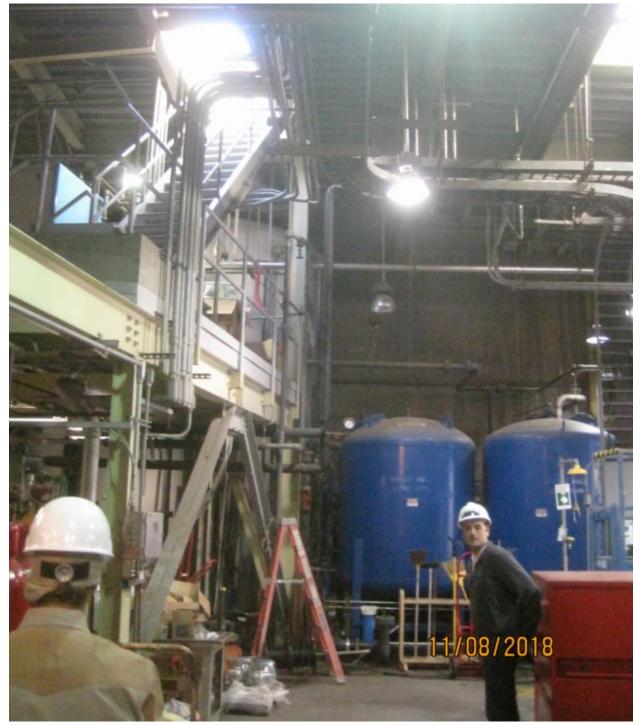
Figure A.5 West Mezzanine (note concentric bracing at interior bays)

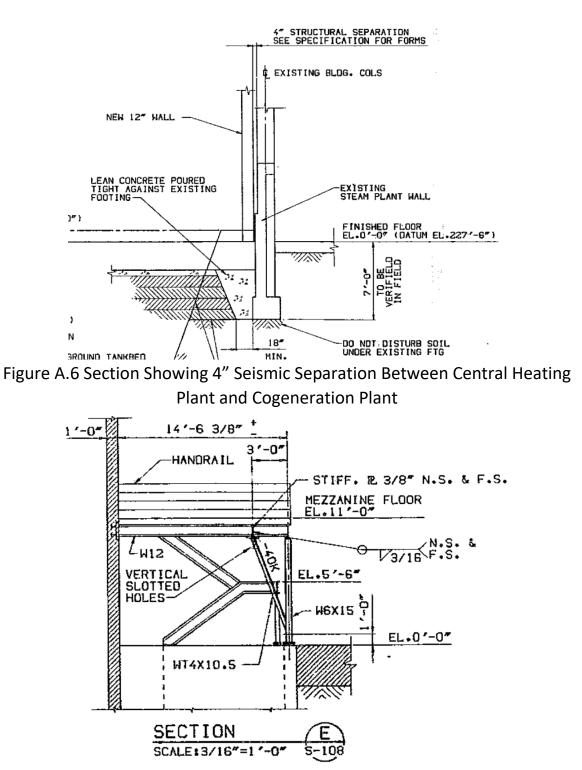
Figure A.7 Section Showing West Mezzanine and Brace. Note "vertical slotted holes" at top of brace.
