Rapid Visual Screening of Buildings for Potential Seismic Hazards
FEMA P-154 Data Collection Form

Address: 590 Gooding Way, Albany, CA Zip: 94706

Building Name: Family Student Housing CD Facility

Screener(s): Bret Lizundia/Ayse Celikbas Date/Time: 11/13/2018 / 1.20 PM

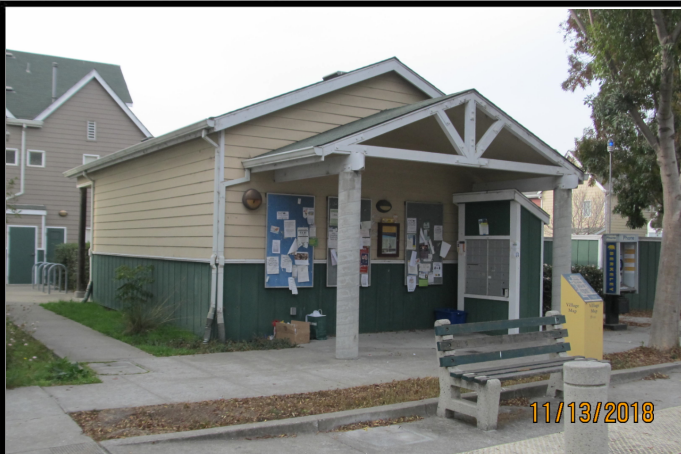
North-South direction forces will impose cross-grain bending in the girders which connect to the top of the concrete columns at the east side.

The concrete columns are cantilevered at the base, and they are 12" diameter circular columns with #3 ties at 12" O.C. They were found to be shear critical.

- The building has a high P-154 Level 1 score of 4.0, good wall distribution, and light loads. An SPL rating of IV is assigned rather than III because the columns in front are shear critical and have a poor connection to the girders, and the site is in a mapped zone of liquefaction with the main building on a mat but the columns on flag pole footing, leading to the possibility of differential settlement.

☐ Yes, unknown FEMA building type or other building
☐ Yes, score less than cut-off
☒ Yes, other hazards present (Liquefaction)
☐ No
