**ASCE 41-17 Tier 1 Seismic Evaluation**Building Name: [Sproul Hall](#)

CAAN ID: 1210

Address: [Barrow Ln, Berkeley, CA 94704](#)Site location coordinates: Latitude [37.8696](#) Longitudinal [-122.2590](#)

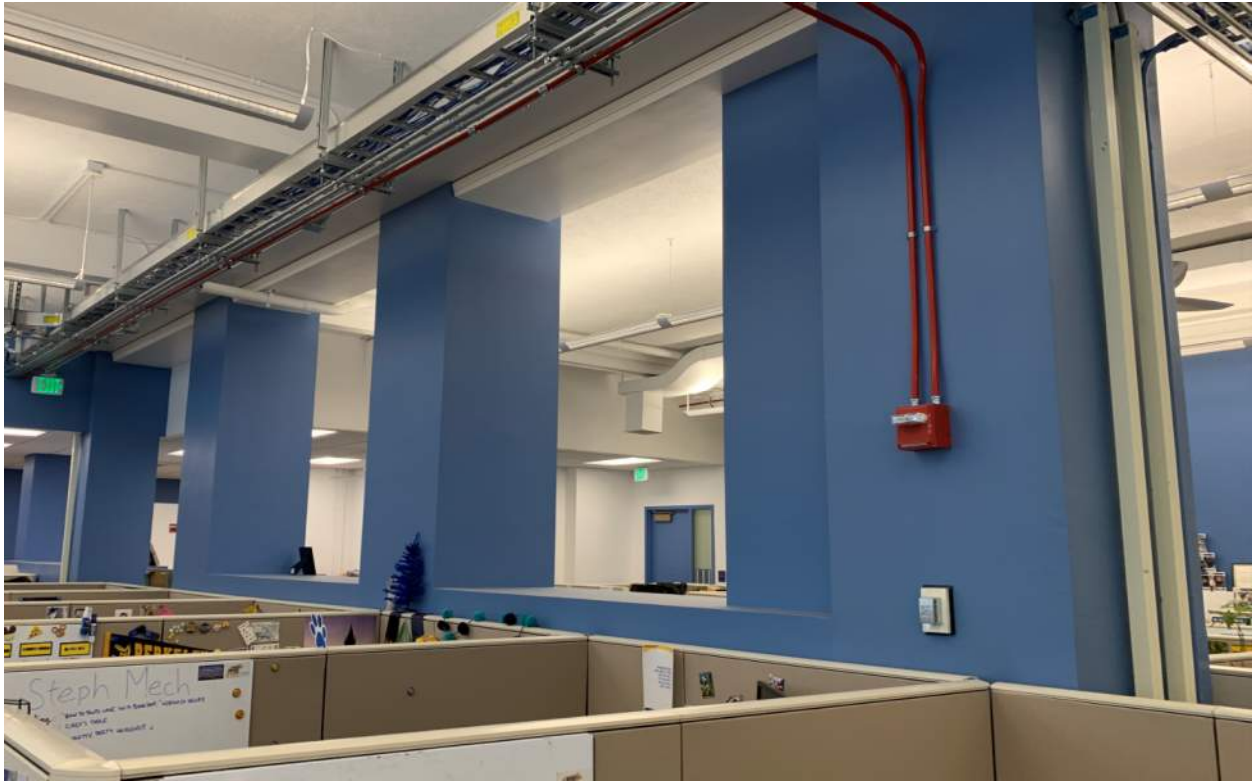
2. *Discontinuous Shear Walls:* Discontinuous shear walls exist on the 2<sup>nd</sup> story and the 4<sup>th</sup> story. The 4<sup>th</sup> floor is discontinuous on transfer girders around the perimeter North, South and West elevations. The overturning forces may overload the beam or its connections. The 2<sup>nd</sup> story discontinuous wall is the East wall of the center portion of the structure. This 162' long, 10" wall is discontinuous over steel columns with 15', 8" wall segment at each end of the wall. This discontinuity may overload these short wall segments, as the discontinuous wall above is half of the lateral system of the central portion of the building in the longitudinal direction.

*Figure 1 Columns at 1st story supporting discontinuous shear walls above*

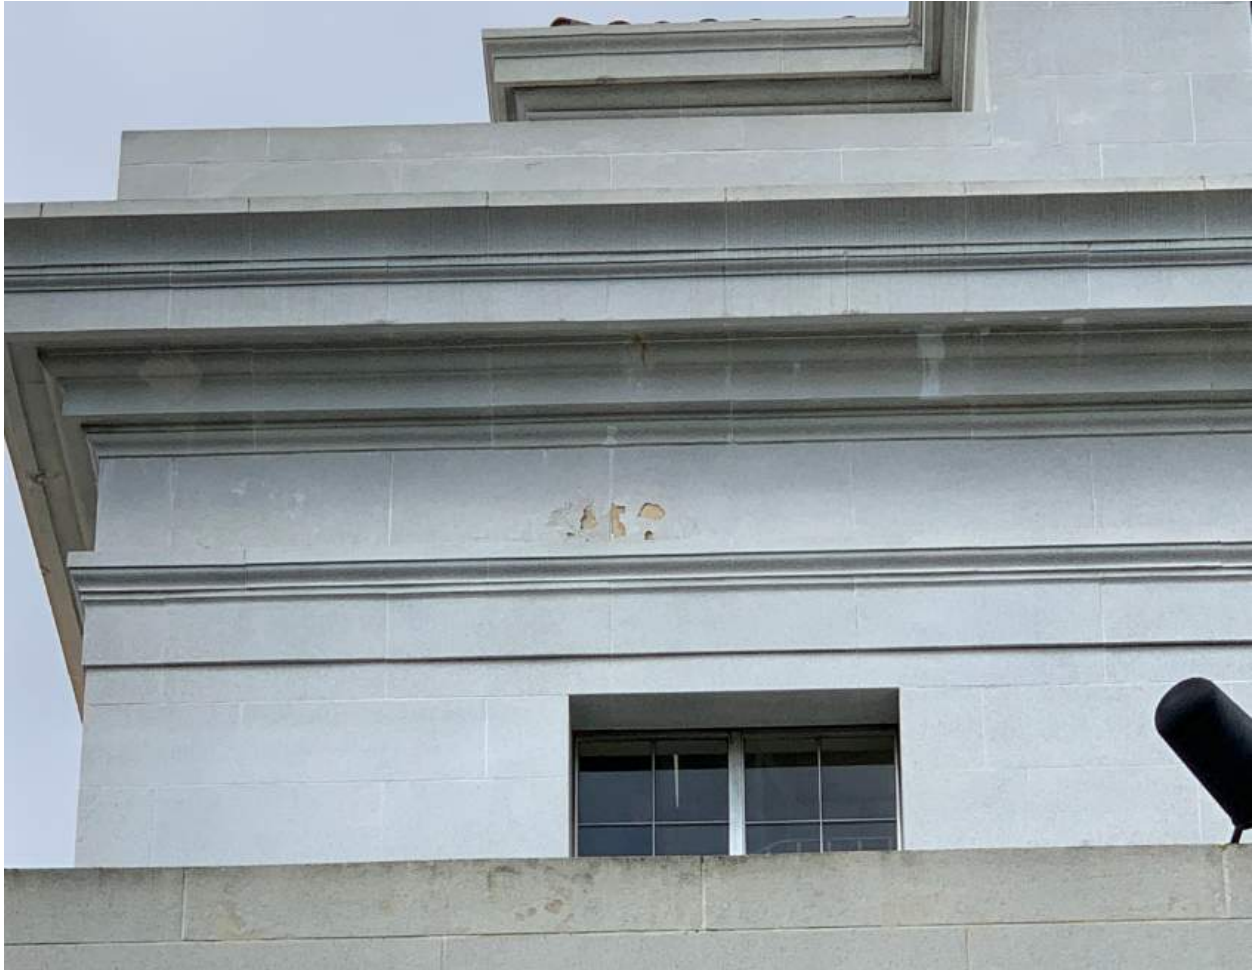
1. Terra cotta clay tile is used on the façade. During this time period, post 1933 Long Beach earthquake, it was common to provide anchorage of terra cotta tiles. The cornices show anchorage but the document available do not show anchorage of the typical façade tiles. This is a hazard because these tiles are located up the height of the structure and could be a life safety hazard during a seismic event if there is not proper anchorage detailing. (See Figures 2 & 3)

*Figure 2 Deterioration in the Terra Cotta facade*

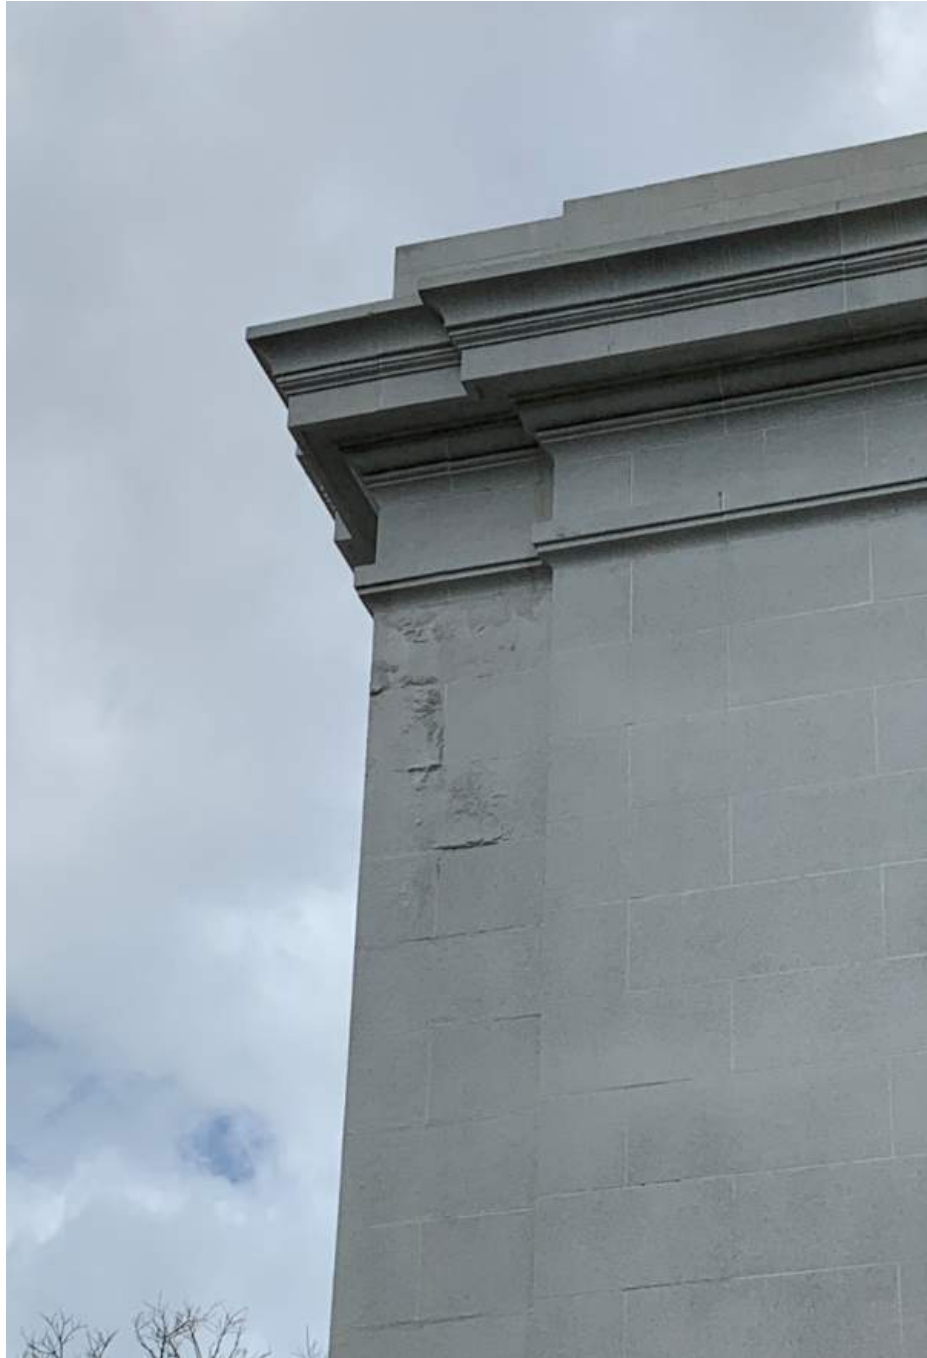
*Figure 3 Terra Cotta deterioration*

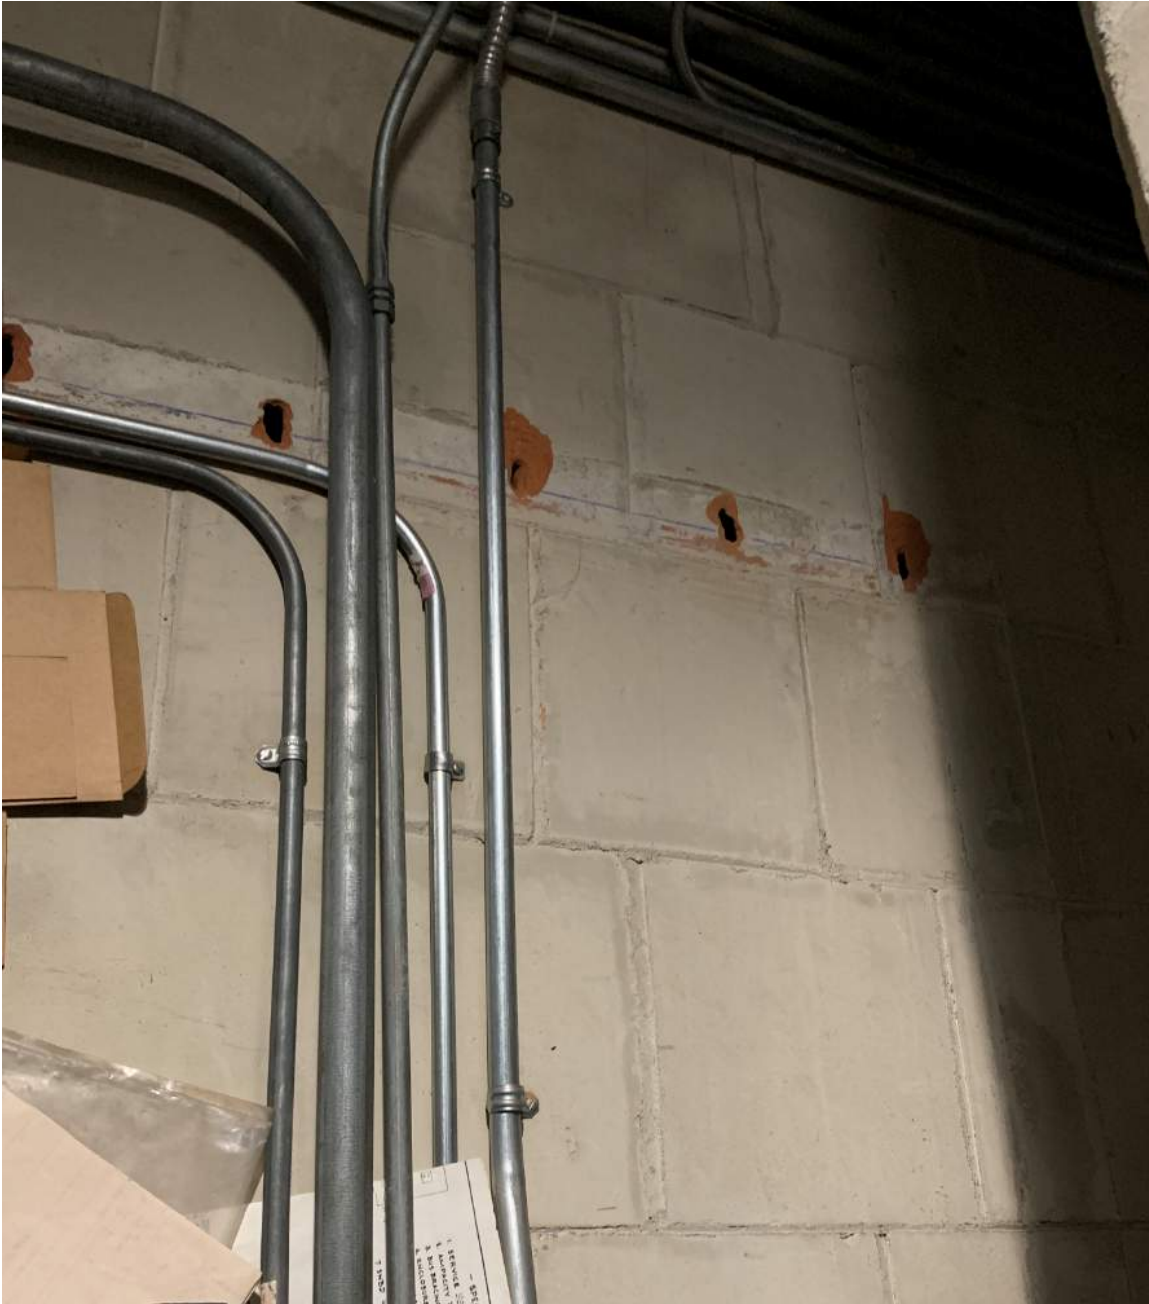
2. Hollow clay tile is used as a partition walls in the basement level. This material is brittle and is susceptible to damage under story drifts caused by earthquake loads. (See Figure 4)

*Figure 4 Hollow Clay Tile Used as Partitions in Basement*

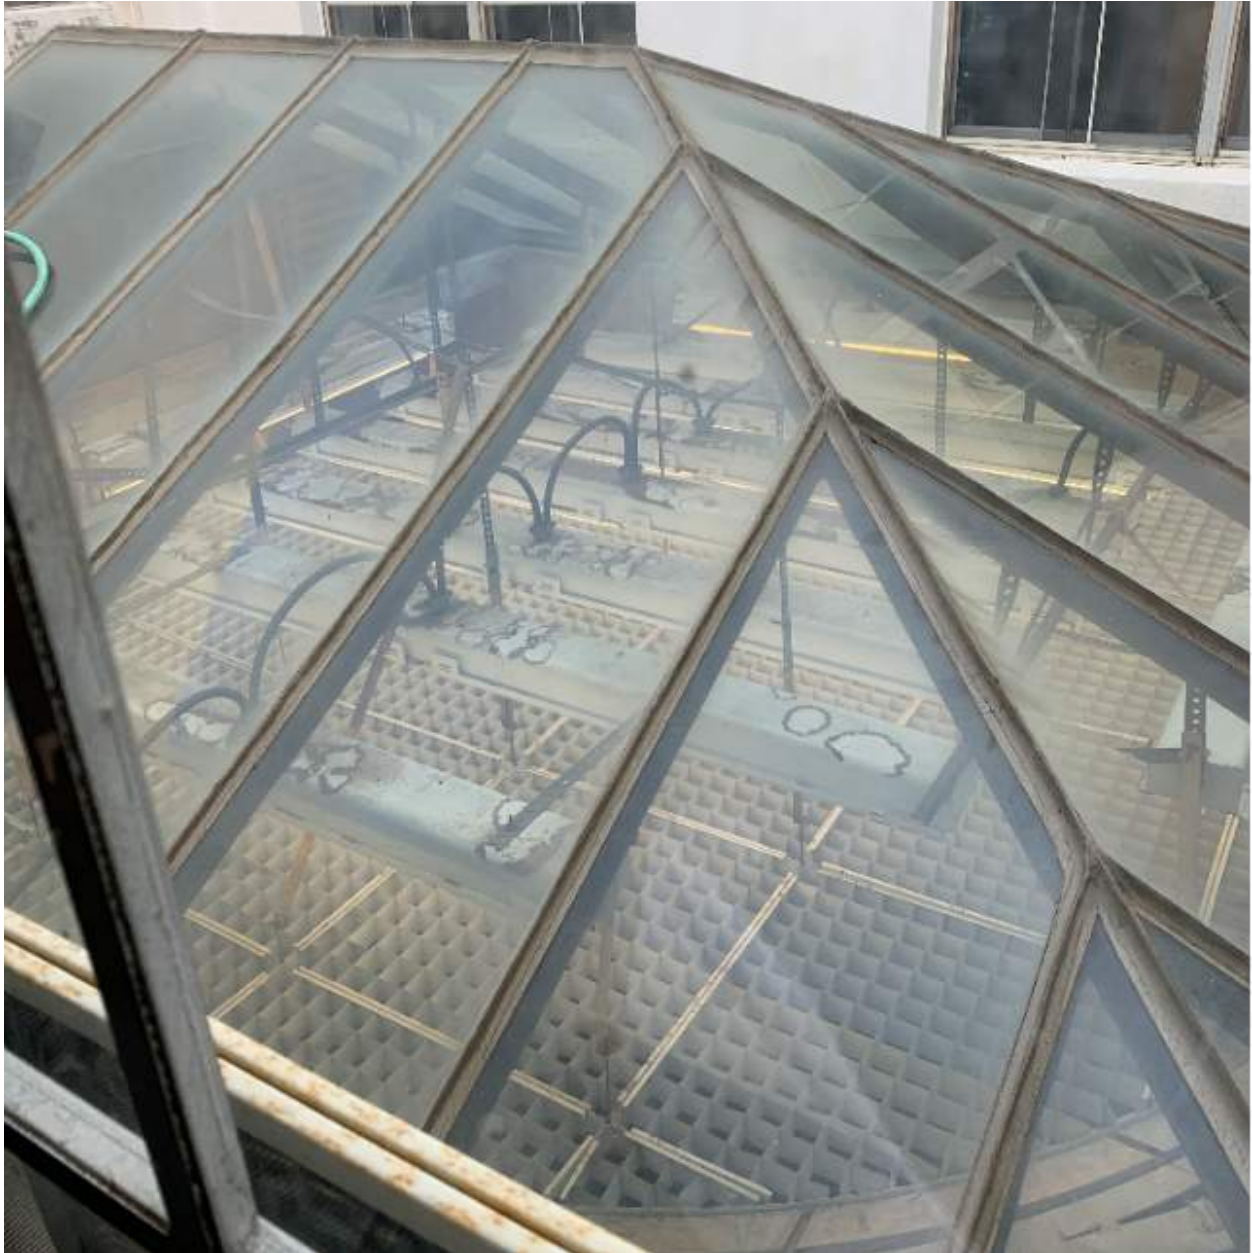
3. There are glass skylights at both the north and south wings that appear to be part of the original construction. The glass does not have embedded wire mesh or appear to be tempered. This may pose a falling hazard in a seismic event. (See Figure 5)

*Figure 5 Glass skylight in the North and South Wings*
