ASCE 41-17 Tier 1 Seismic EvaluationBuilding Name: **Recreational Sports Facility, Handball**

CAAN ID: 1365

Address: **Core Campus, Berkeley, CA 94720**

Date of Site Visit: 02/15/2019, Ray Pugliesi & Torrey Bolden, Degenkolb Engineers

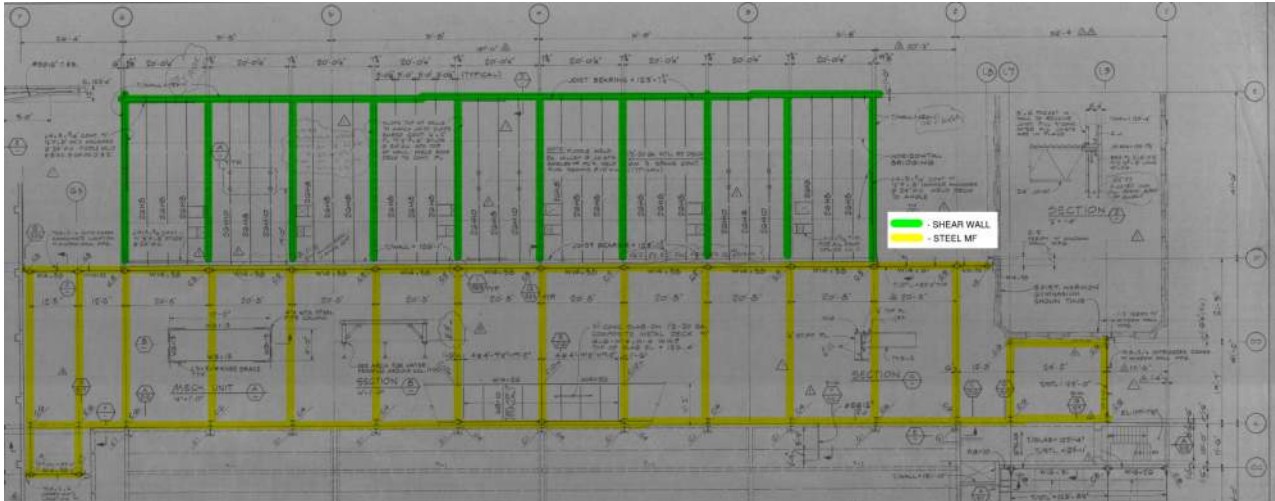
Lateral Force Resisting System Layout

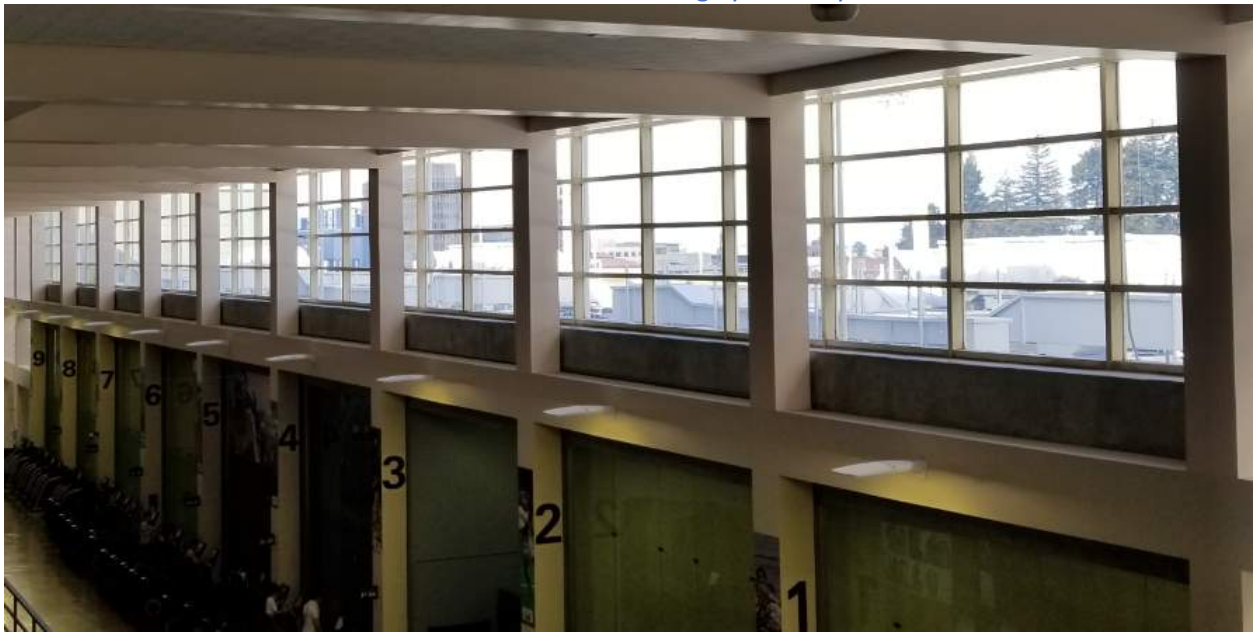
3. *Drift Check* - The moment frame is flexible in the East-West direction due to all of the columns being framed in the weak axis. This increased flexibility is resulting in a ~5.0% inter-story drift at the first floor per the quick check procedure, and significantly more drift at GL D if a flexible diaphragm is considered. This drift demand indicates the potential for significant structural and non-structural damage.

This structure has been assigned a SPL rating of V mainly due to the large drift demands at GL D and a system of Pre-Northridge moment connections and non-compact members at this frame. Preliminarily, this large deflection expectation can be attributed to the flexible diaphragm and the moment frame supporting the transverse shear walls out of plane. A more detailed Tier 2 or Tier 3 analysis will provide a better understanding of the force distribution and ductility demands to better evaluate the importance of the current identified deficiencies.

Moment Frame on Gridline D

Potential Retrofit Scheme: Diaphragm strengthening at the low roof with in plane structural steel bracing would help the system better distribute forces to the concrete shear walls and alleviate the demand in the moment frame at the shear wall. The moment frame could be strengthened with moment connection retrofits, intermediate beam bracing and column stiffening or BRB's could be installed in select bays to provide adequate stiffness in the moment frame directions.

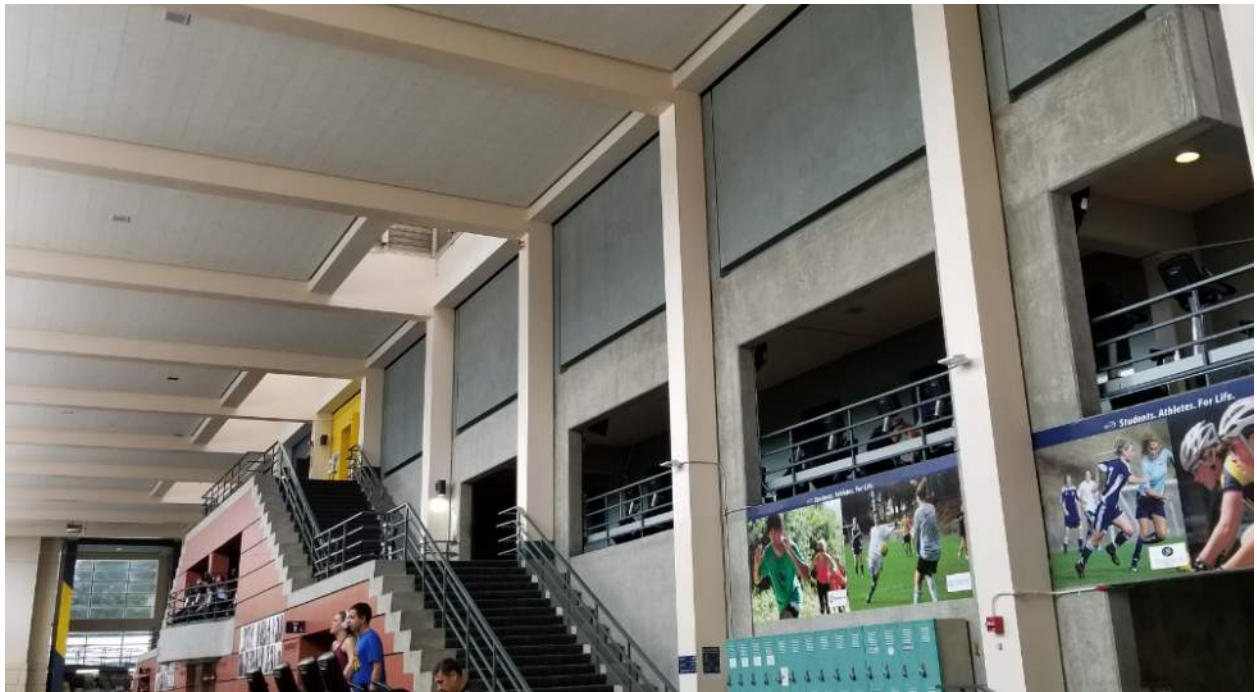
Mezzanine Elevation on Gridline C

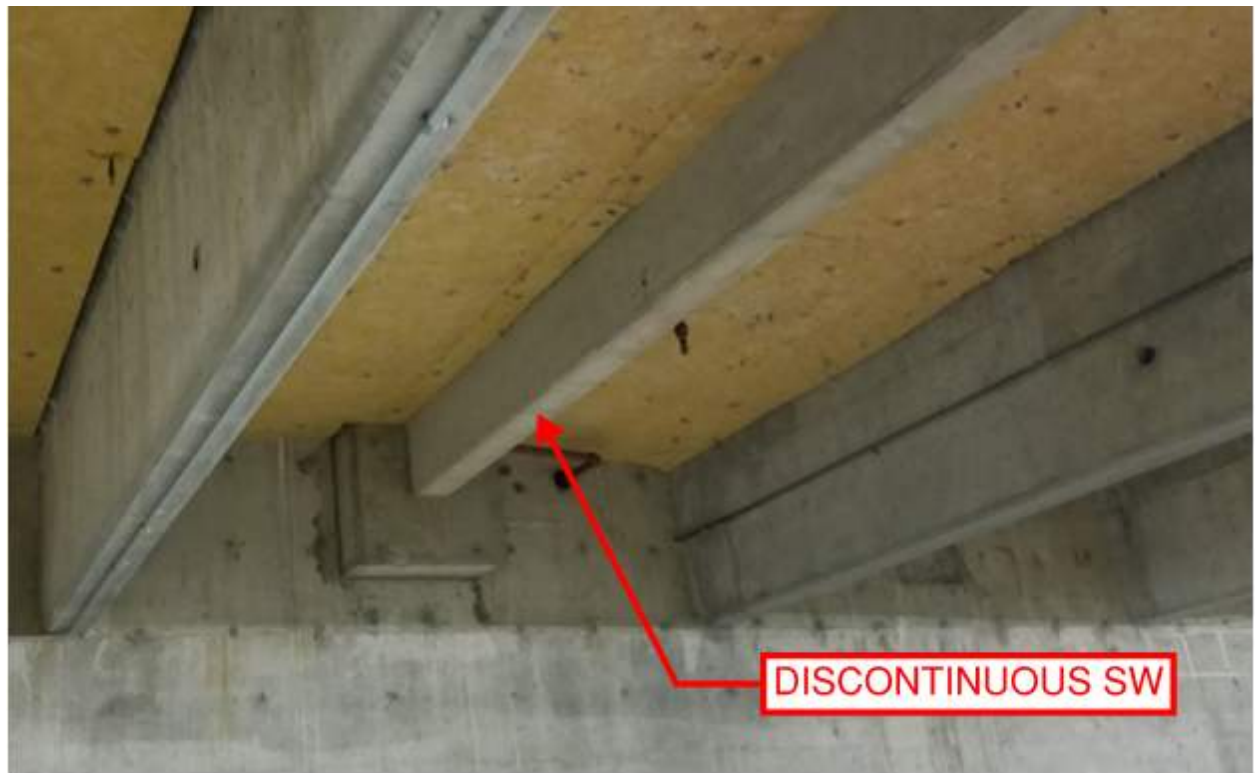
5. *Vertical Irregularity* – The transverse shear walls are discontinuous at the ground floor, and rely on the diaphragm to transfer shear forces to the walls that are doweled into the foundation. The shear wall ends land on perpendicular shear walls below grade, and this is expected to mitigate any potential damage caused by overturning in the walls. The North-East portion of the structure is suspended over existing racquetball courts, and transverse walls land on cast in place beams.

Discontinuous Transverse Shear Wall Shown Between Precast Tee Flanged Sections
