ASCE 41-17 Tier 1 Seismic Evaluation

Building Name: **Recreational Sports Facility, Lobby**

CAAN ID: **1365**

Address: **Core Campus, Berkeley, CA 94720**

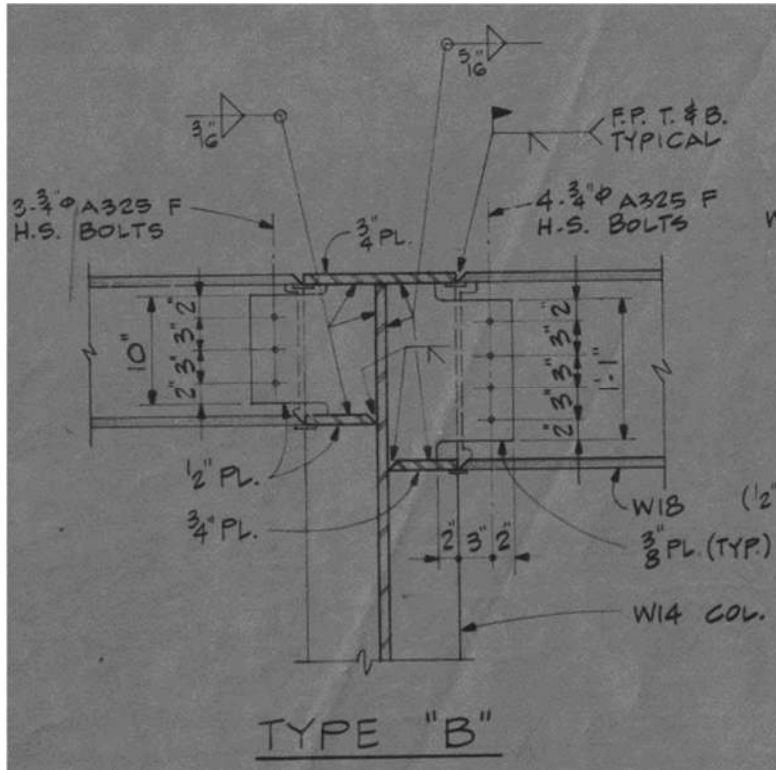
2. *Moment Resisting Connections:* The moment connection utilized is a Pre-Northridge, Welded Unreinforced Flange (WUF) connection. This connection type is non-compliant and requires a more detailed analysis.

Typical Moment Frame Connection

Potential Retrofit Scheme: Strengthen the moment connection to provide improved performance. Potential retrofit connection configurations are described in FEMA 351, chapter 6. In addition to connection strengthening, beam bracing, and column stiffening may be necessary pending a more detailed analysis.
