ASCE 41-17 Tier 1 Seismic EvaluationBuilding Name: **Recreational Sports Facility, Fieldhouse**CAAN ID: **1365**Auxiliary Building ID: **1365.3**Address: **Core Campus, Berkeley, CA 94720**Site location coordinates: Latitude **37.8686** Longitudinal **-122.2623**

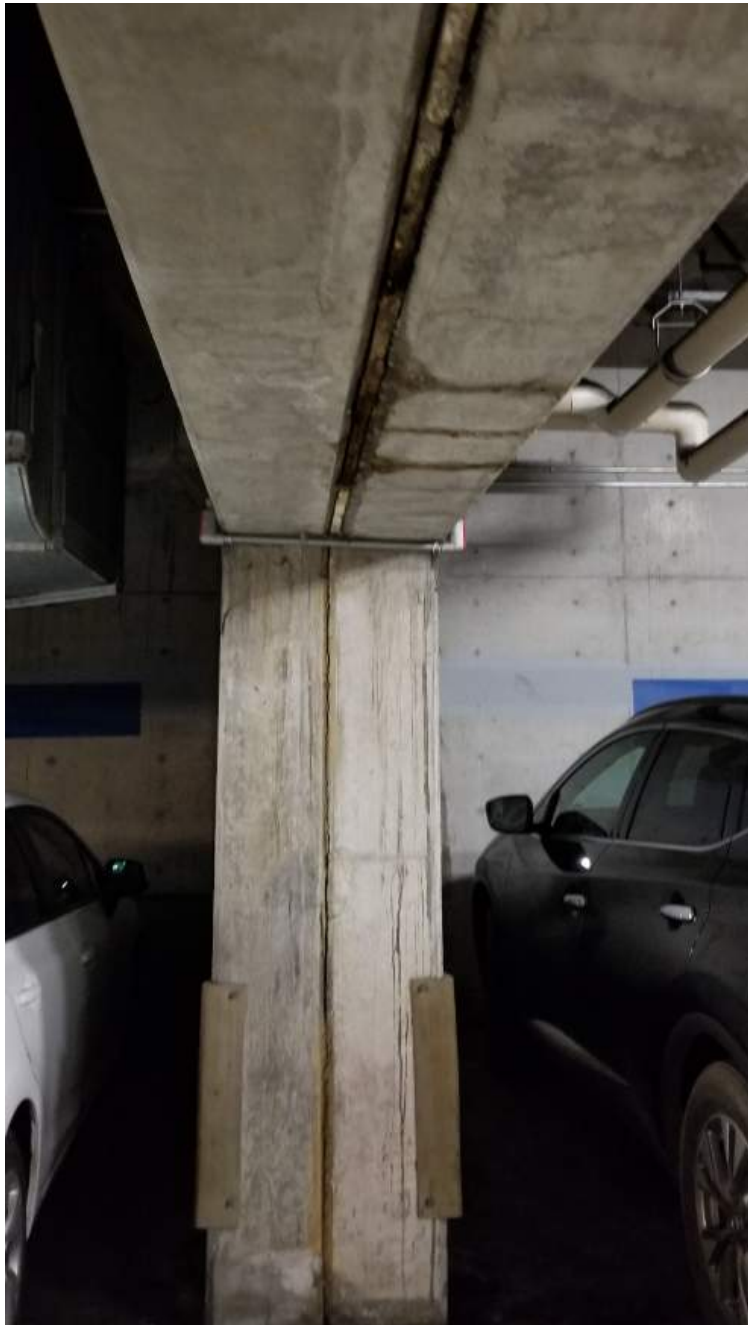
2. *Adjacent Buildings* - Seismic joints between the adjacent structures are inadequate for the expected displacements. The roof levels of the adjacent Handball superstructure does align with the roof diaphragm in the Fieldhouse Superstructure. The alignment of the stories should mitigate the structural damage related to pounding.

Seismic Joint Where Building Share a Pile Foundation on GL 7

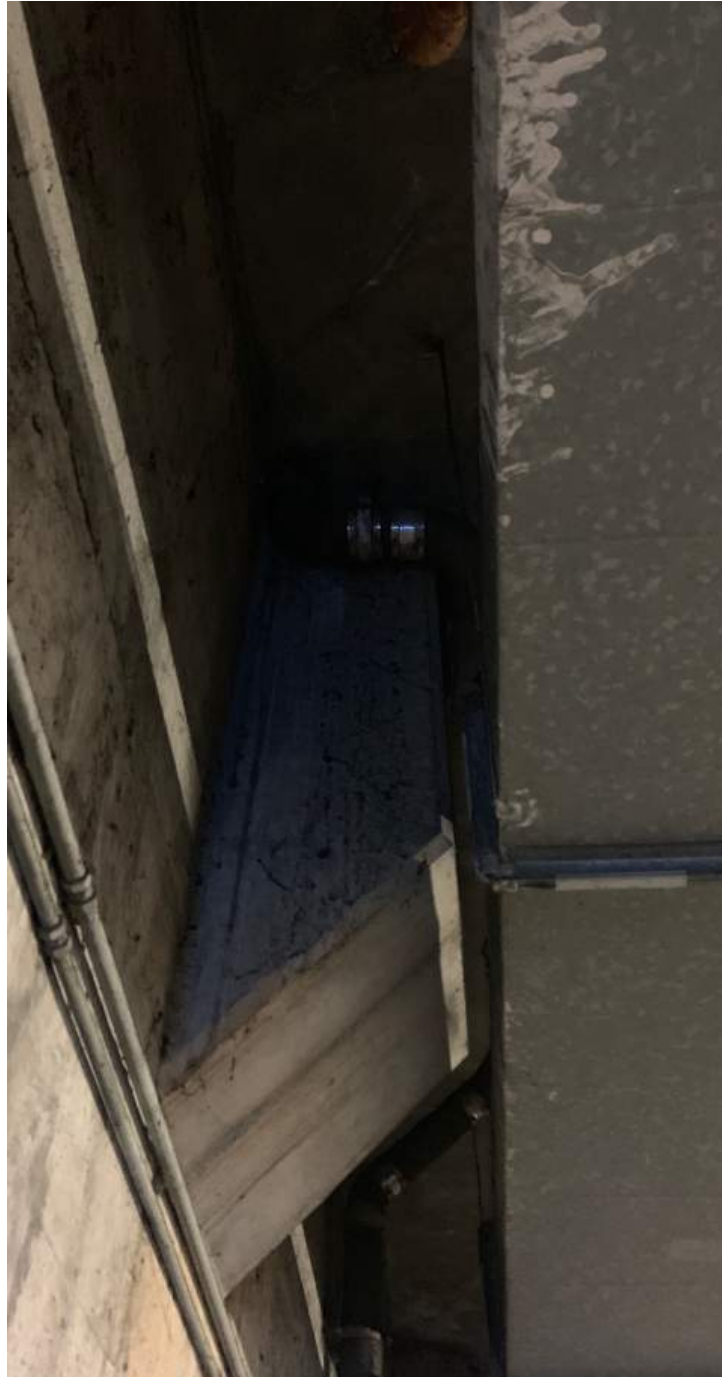
Haunch Supporting Braced Frame Columns

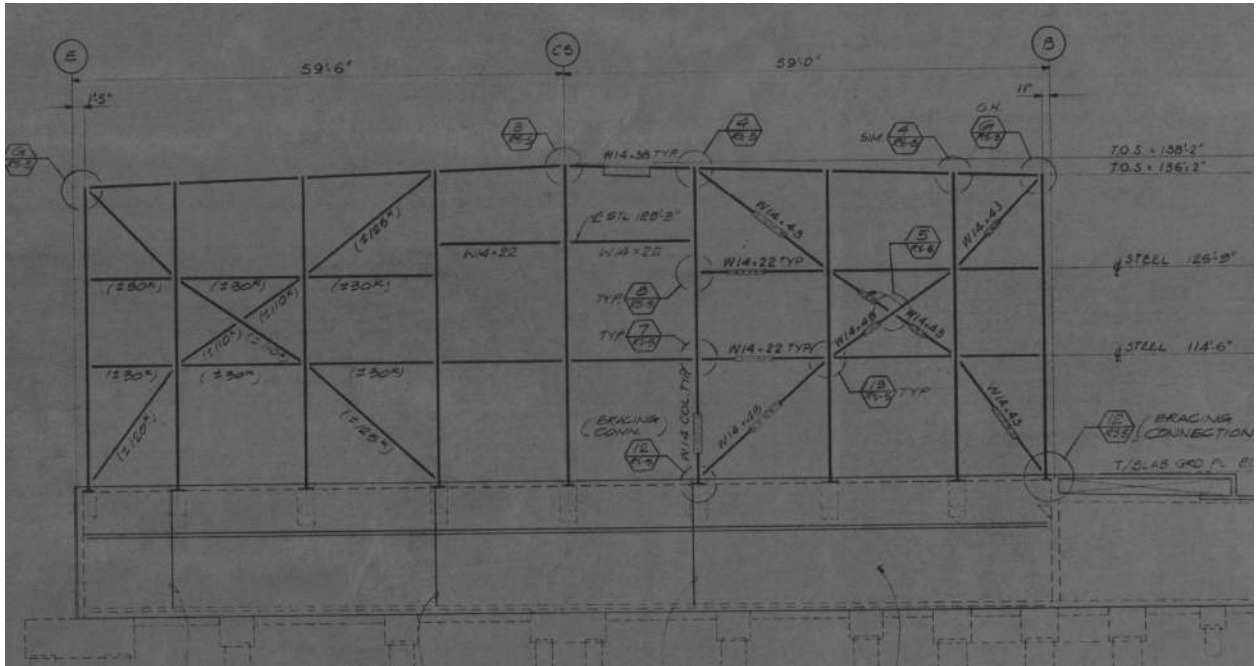
1. *Connection Strength* – The brace connections are shown on the construction documents as a deferred items. The W14x43 braces are referenced with a 100k connection strength and the tensile capacity of the brace far exceeds this design strength. This deficiency could lead to a loss of the structural system.

Transverse Braced Frame Elevation

The main deficiency of this structure is a result of poor brace connections. The brace connections could be strengthened or the members could be replaced, possibly with BRBs, and the appropriate connections. Column strengthening may also be required to facilitate the new bracing system.

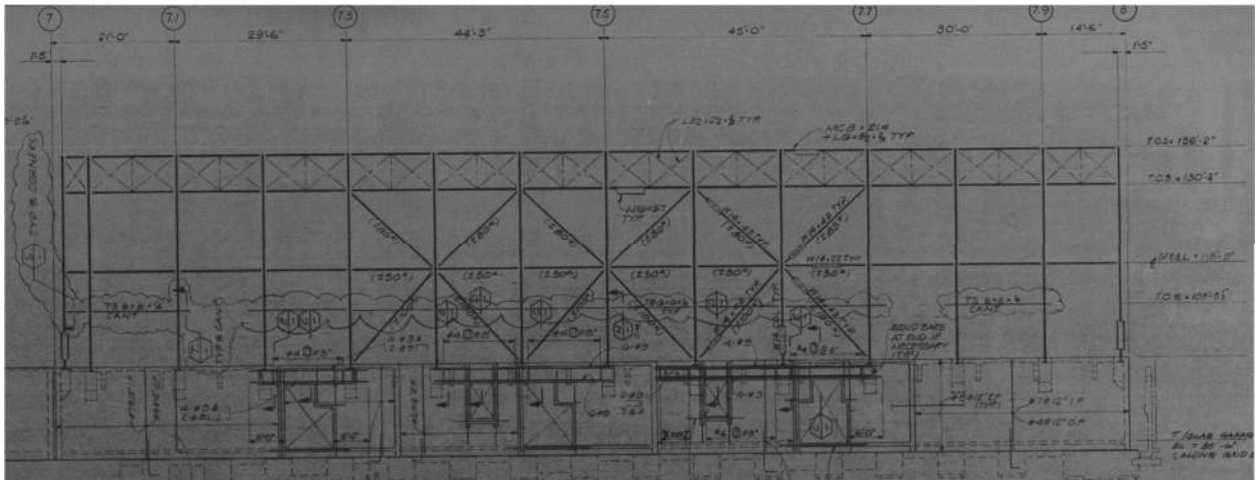
Longitudinal Braced Frame Elevation
