**Rapid Visual Screening of Buildings for Potential Seismic Hazards**

FEMA P-154 Data Collection Form

Address: Grizzly Peak & Centennial Drive  
Berkeley Zip: 94705

Building Name: Silver Storage

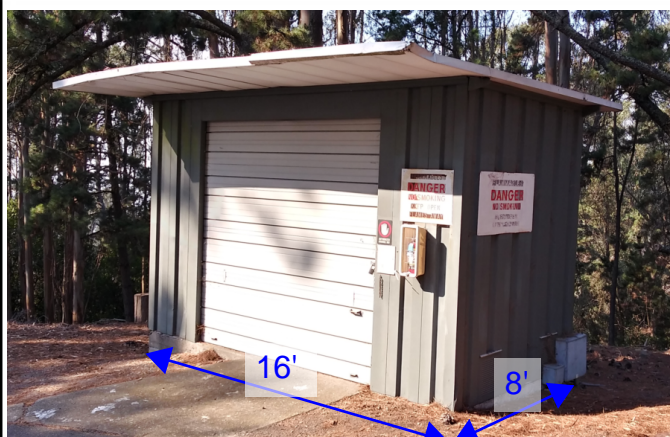
The front is a large opening for the roll-up door, creating some potential torsional offset. However, the roof and walls are light gage steel with no other contribution for mass. Hazardous contents not anchored.

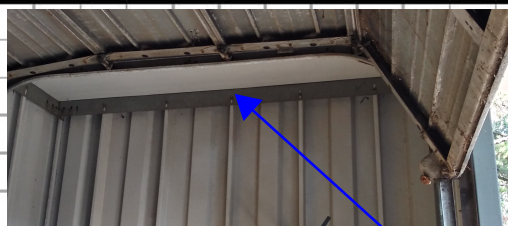
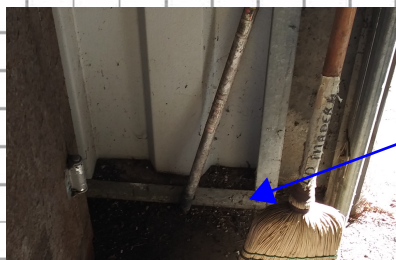
Top photo shows regular and positive connection between the walls and the roof.  
 Bottom photo shows similar connection between the walls and the foundation.
