**ASCE 41-17 Tier 1 Seismic Evaluation**

Building Name: American Baptist Seminary, Karpe Hall

Address: 2521 Hillegass Avenue, Berkeley, CA 94704

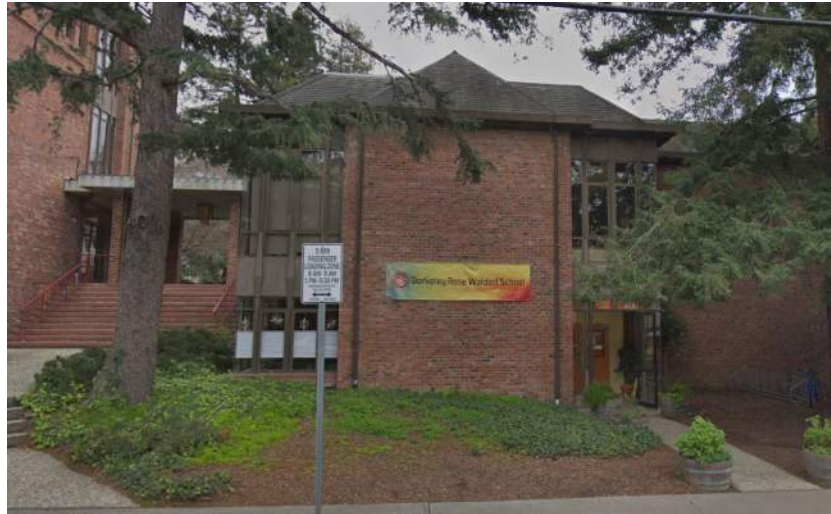
West Exterior Elevation

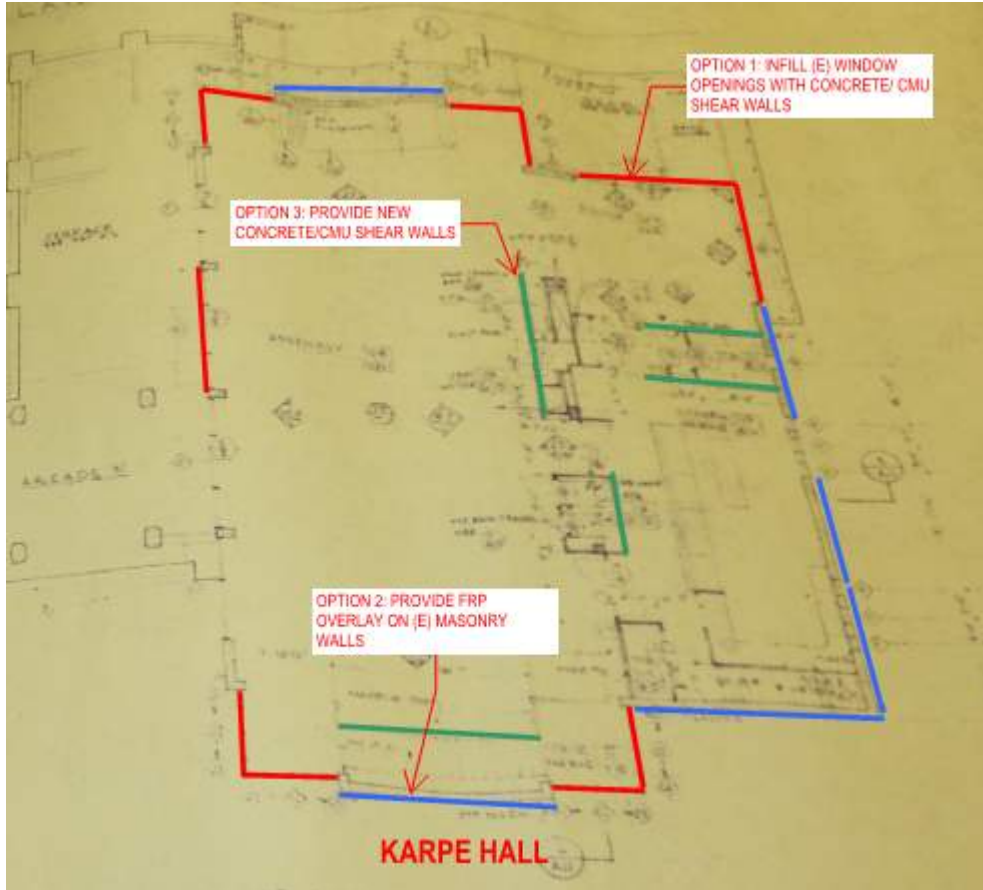
*Preliminary proposed retrofit schemes*

In order to increase the shear capacity of the shear walls some of the window openings can be infilled with concrete or masonry, additional interior masonry walls can be built, or Fiber Reinforced Polymer (FRP) overlay can be applied to existing walls to increase shear capacity.

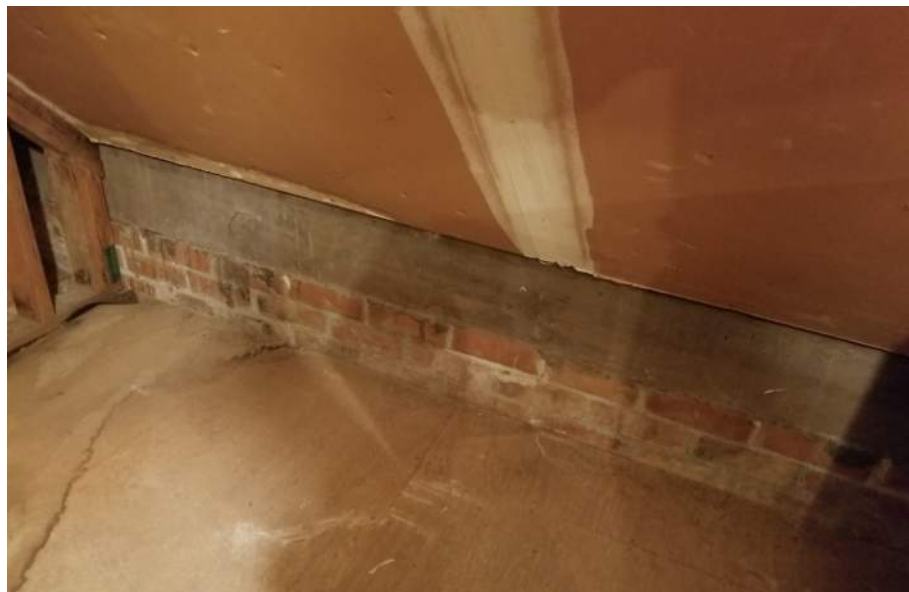
*Concrete bond beam at top of masonry wall at Attic Level*

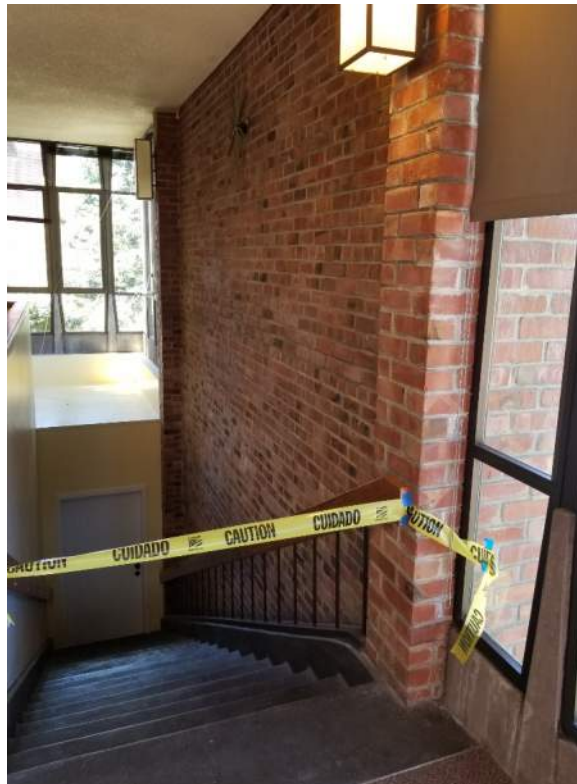
3. *Openings at Shear Walls:* A large diaphragm opening along the west shear wall occurs at the First Floor. Cracking around the opening corners may occur during an earthquake due to stress concentration. Existing drawings of the building are not available to understand if the floor was detailed adequately with reinforcing around this opening to prevent cracking and have an adequate diaphragm force transfer around the opening.

4. *Masonry or Concrete Wall Anchorage at Flexible Diaphragm:* The out of plane anchorage of the two story masonry wall above the stair opening at the First Floor is inadequate, and the diaphragm may pull away from the wall in case of a seismic event and may cause a partial collapse of the roof.

*Large stair opening in the diaphragm at First Floor next to the exterior shear wall causing a two story wall*

Due to lack of as built drawings, it is recommended that investigative and materials testing should be performed to understand the constitution of the shear walls, followed by a Tier 2 analysis. A limited retrofit to increase the shear capacity of shear walls may be necessary to address the identified deficiencies and improve the SPL rating to IV.

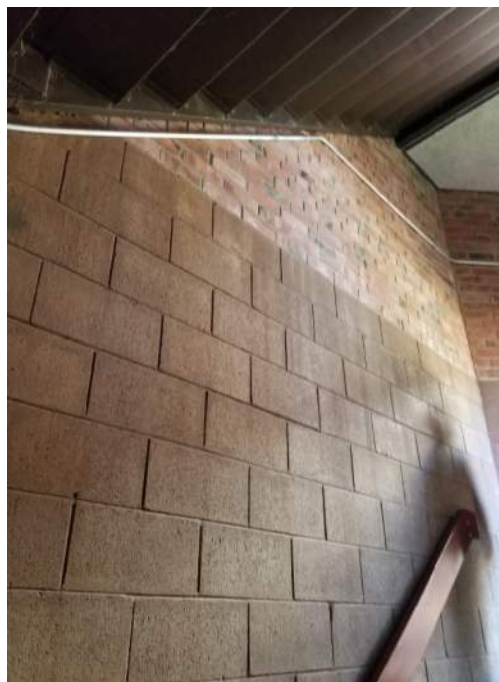
*A combination of coneret masonry at the Basement and brick masonry at the upper levels ahs been used in Karpe Hall*

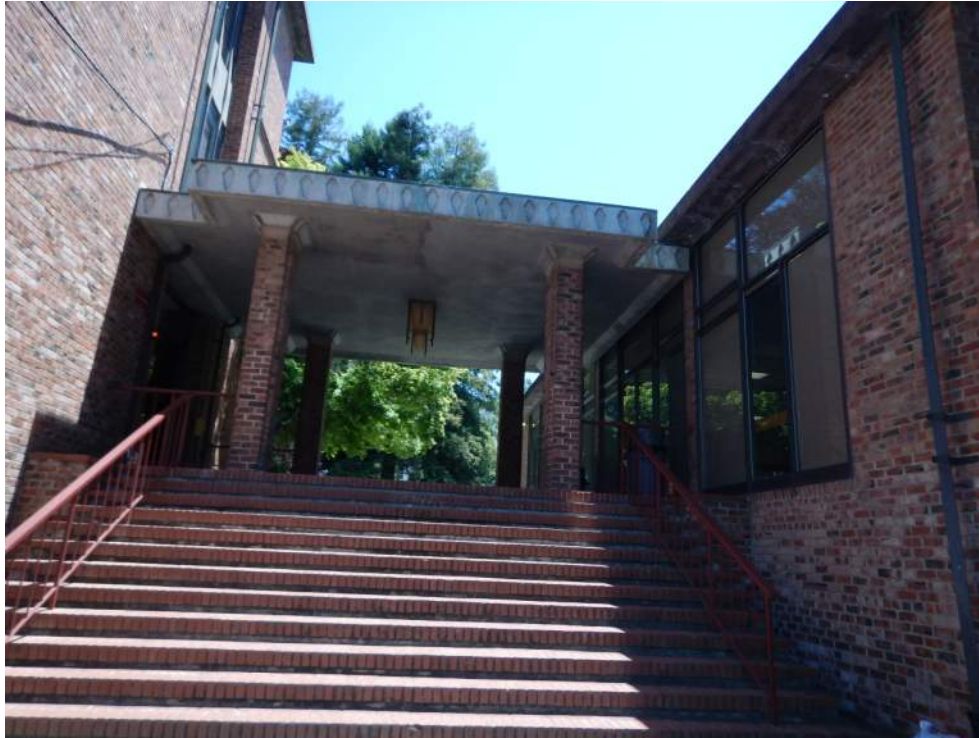
2. *Adjacent Buildings:* Karpe Hall is connected to the Academic Building via a two story, covered walkway. The walkway roof almost aligns with the Roof of Karpe Hall and Second Floor of Academic Building. Due to a small joint, pounding is expected between the walkway roof and Academic Building in the north-south direction, but minimal structural damage is anticipated since the floor levels almost align. Although there is a structural separation between the walkway roof and Karpe Hall, in the east-west direction, the canopy roof is 'locked' into the door cavity of the Academic Building. The Academic Building is structurally stiffer than the walkway cantilever columns, and will resist movement of the walkway roof, but the far side of the roof (near Karpe Hall) is free to move. This will cause significant torsion in the walkway roof and increased demands and damage to the cantilevered columns. Some cracks may appear in the roof slab and columns due to unequal load distribution due to torsion.

*Walkway between Karpe Hall and Academic Building*
