Rapid Visual Screening of Buildings for Potential Seismic Hazards
FEMA P-154 Data Collection Form

Address: 590 Gooding Way, Albany, CA Zip: 94706

Building Name: Family Student Housing CD Facility

Screener(s): Bret Lizundia/Ayse Celikbas Date/Time: 11/13/2018 / 1.20 PM

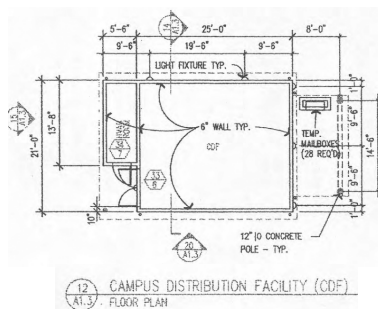
North-South direction forces will impose cross-grain bending in the girders which connect to the top of the concrete columns at the east side.

The concrete columns are cantilevered at the base, and they are 12" diameter circular columns with #3 ties at 12" O.C. They were found to be shear critical.
